## **TEST REPORT No. 369683**

waterproofing membrane named "Bituver Monoplus"

# hail resistance according to standard UNI EN 13583:2012

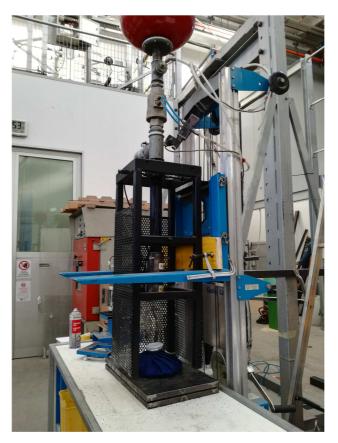
Photograph of a specimen during the test

Type of support	Specimen	Velocity	Effect
		[m/s]	
	1	18,5	slight superficial sign at the point of impact
	2	18,9	slight superficial sign at the point of impact
soft	3	18,9	slight superficial sign at the point of impact
	4	18,6	slight superficial sign at the point of impact
	5	18,7	slight superficial sign at the point of impact
Aver	age	18,7	//
