TEST REPORT No. 369685

**waterproofing membrane named
"Bituver Renover"**

**hail resistance according
to standard UNI EN 13583:2012**

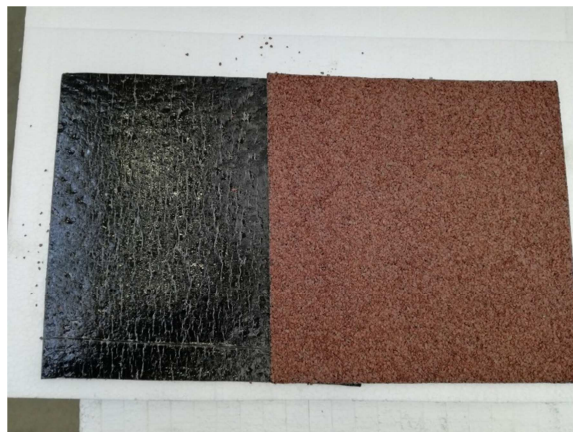
5 specimens, dimensions 250 mm × 250 mm and thickness equal to that of origin, were cut by the customer from the item.

Photograph of a specimen

The sample under test consists of a waterproofing membrane with double compound BPE+APAO, with slate top finish, thickness 4 mm.

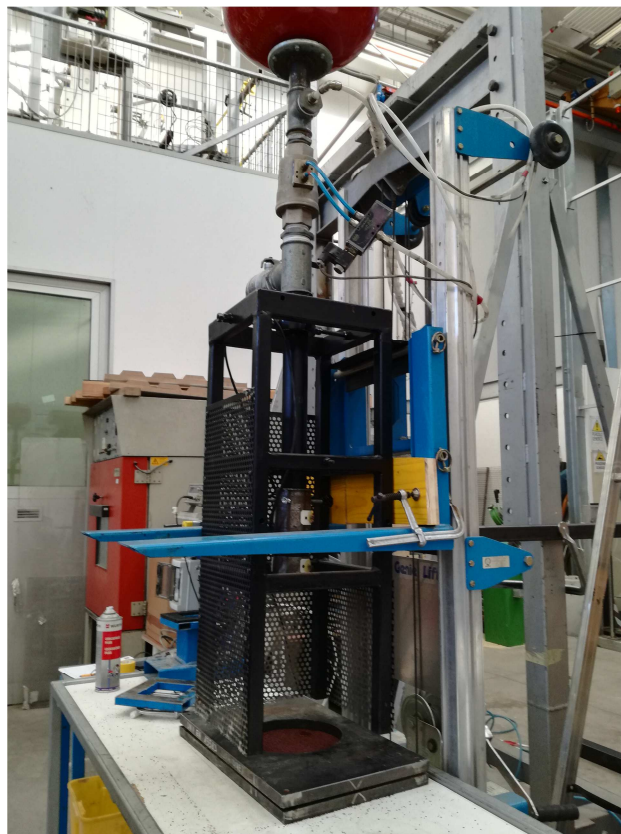
Photograph of a specimen during the test

Normative reference	Activity	Description
clause 6.2	Conditioning	(23 ± 2) °C temperature (50 ± 10) % relative humidity 24 h
clause 8	Determining damaging velocity	"v _d " defined as the velocity leading to maximum one perforation for a set of 5 specimens.

Type of support	Specimen	Velocity [m/s]	Effect
soft	1	33,7	slight superficial sign at the point of impact
	2	33,7	slight superficial sign at the point of impact
	3	34,1	slight superficial sign at the point of impact
	4	33,9	slight superficial sign at the point of impact
	5	34,1	slight superficial sign at the point of impact
Average		33,9	//
